04 - ERGONOMIC WORK ANALYSIS OF THE WAREHOUSE WORK STATION ON BUILDING CONSTRUCTION: A CASE STUDY

The objective of this work is to verify the ergonomic conditions of the job of a warehouse construction in the concerns of Regulatory Standards 17 and 18.

It was selected a medium sized construction company, operating in the southern region of the country in the area of residential buildings. It was chosen a coating work phase construction, the phases being a longer and higher turnover of materials.

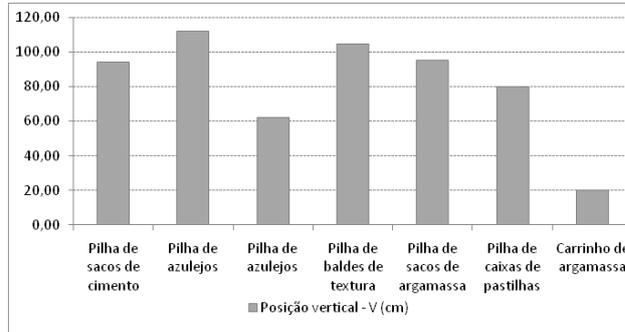
The piles of materials were stable and, mostly, the facilitated height handling. As shown in the graph of Figure 1, the stacks of material were between 80 cm and 1.10 m, ie in the range of reach. The exception was the second stack of tiles, which was 60 cm. Furthermore, the wheelbarrow had 20 cm and also demanded squat. The materials were stacked on wooden pallets 10 cm to not allow the materials were in an unstable, damp and uneven, according to item 18.24.5 of NR 18 (BRASIL, 2013b).

Figure 1: height disposal of materials.

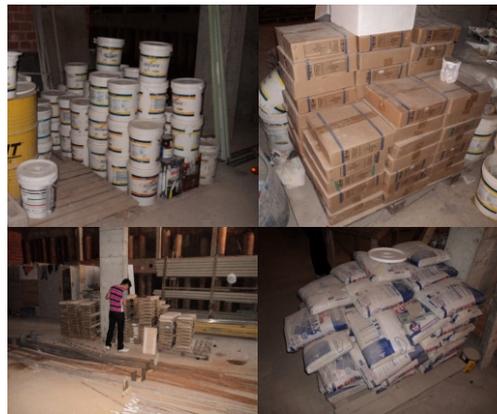
On the other hand, PVC pipes were arranged in layers, separated with spacers and gauges brace as seen in Figure 2.

Figure 2. Above and left: stack of buckets texture, top right: stack of boxes pellets; below and to the left: stack of boxes of tiles and PVC pipes to the bottom, bottom right: stack of bags of mortar.

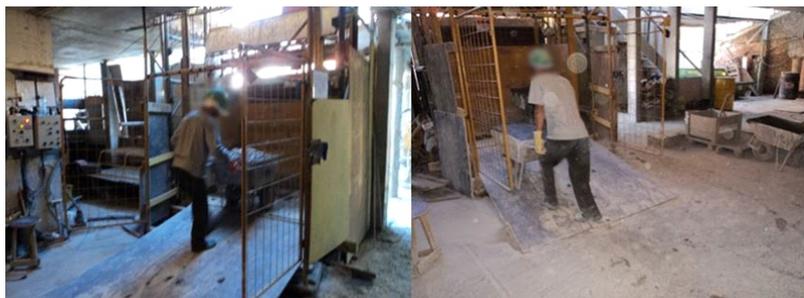
Regarding the movement performed by the worker to perform the task, there is the difficulty of handling the wheelbarrow comprising on average 40 kg to reverse down the ramp after receiving the material, as shown in Figure 3.

Figure 3. Left: Worker carrying the load off the elevator reversed and to the right: worker carrying the load into the elevator.

The verified loads in site were classified between average and high risks, indicating the need of task redesign or submission for another professional to execute them. It is possible that the elevated risks of the loads are related to the pain occurrence indicated by the worker.
